# **DECONTAMINATION AND REMEDIATION WORKS AT ALBRIGHT & WILSON, PORTISHEAD**

*Martyn John Duffin BSc MSc DIC FGS*

## **ABSTRACT**

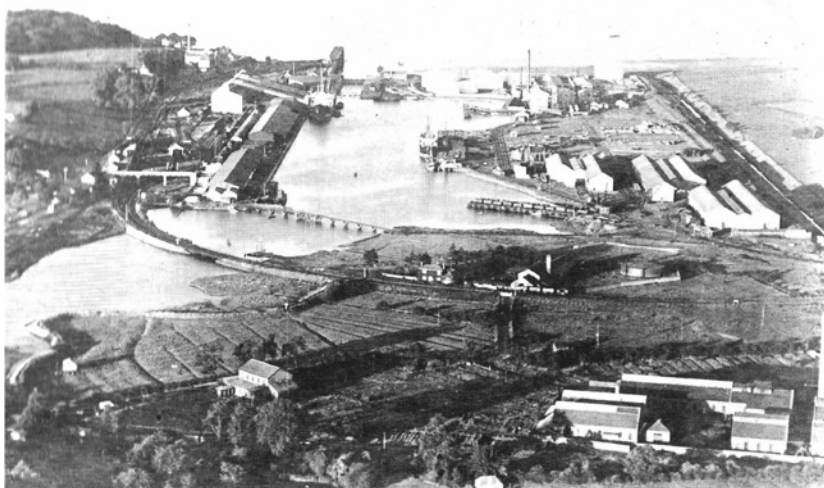
## **The Docks 1930**

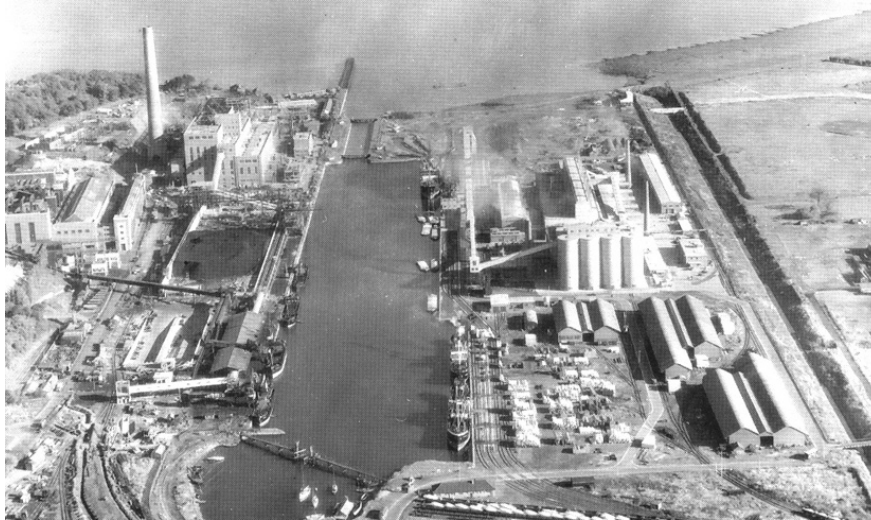
### The Docks 1960

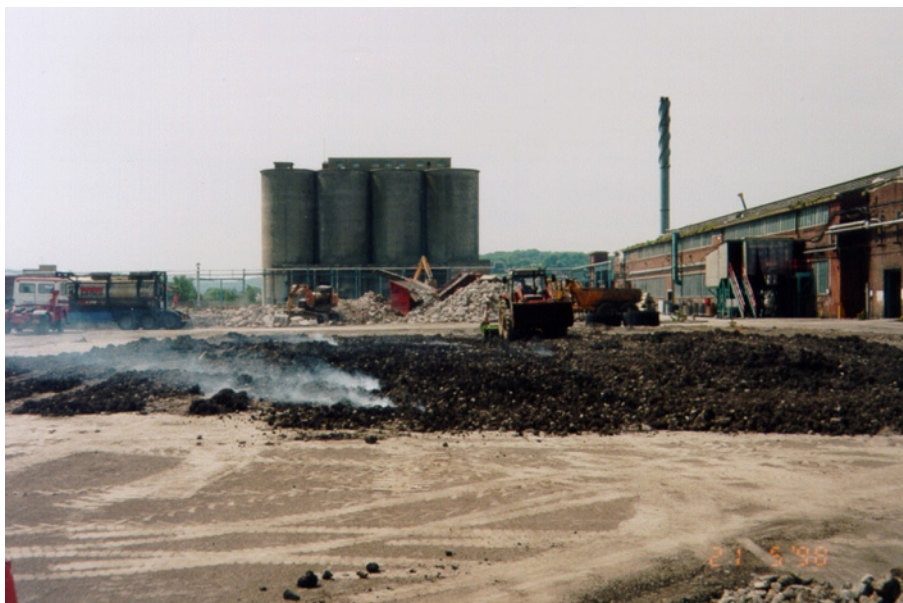
## **Oxidation**

In the 1980's, Albright & Wilson had built three 'stills' in which skips of mud were heated in an inert atmosphere in a bath of molten lead to drive off and recover the phosphorus for recovery. These stills were used to process the phosphorus residues recovered from the site. However, their throughput was limited to a few tons per week and large volumes of relatively mildly contaminated material was being generated and stored as the work progressed. Advantage was taken of phosphorus' propensity to fume at concentrations of 10ppm or less by spreading the generally clayey and fine grained materials in layers 150mm or so thick on the large concrete slabs on site. This was regularly worked over using agricultural tilling machinery and the phosphorus allowed to oxidise and 'fume off' naturally.

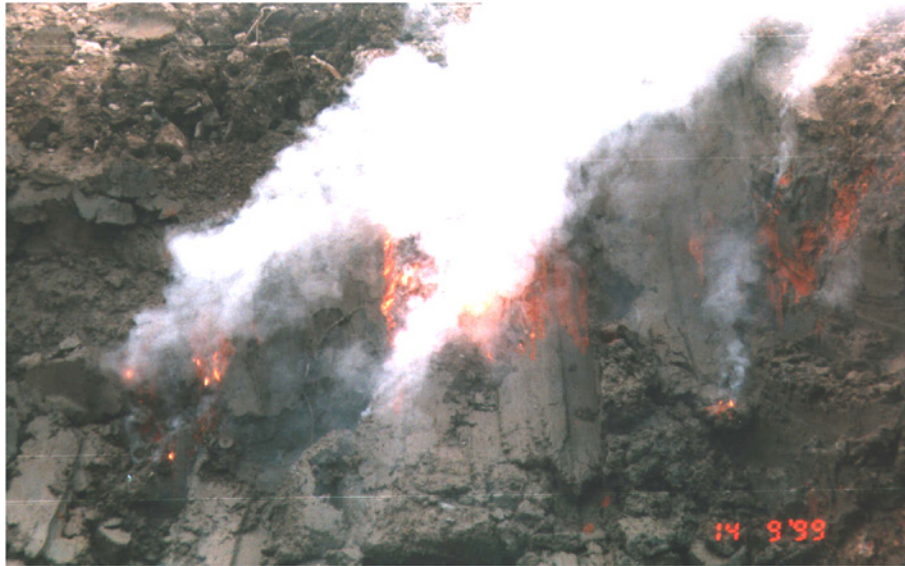
### Phosphorus in 'worm holes'

Pits dug into the tanks in the early investigations showed that they had been filled with 'type 1' crushed limestone with no apparent phosphorus residues. Indeed none were expected. However, when the time came to dig out the tanks, it became apparent that there was a large quantity of yellow phosphorus in the gravel backfill outside of the tanks. Indeed it could be described as 'phosphorus concrete'.

Further research with former employees revealed that, to deal with a minor crisis in the works, phosphorus had been put into the concrete tanks for temporary storage. When the time came for its removal, steam lances were used to melt the solidified phosphorus so that in due course it could be pumped out. However, when the pumps were turned on, mostly hot water came out. Several tonnes of phosphorus had 'disappeared'. When molten at 60°C, phosphorus with its specific gravity of 2.7 and minimal surface tension has the penetrating power of 'heavy' WD40. It had clearly gone straight through the 150mm concrete walls to collect and solidify in the cooler gravel surround. On excavation it was also found to have penetrated into desiccation cracks and old worm and root holes in the alluvium as well as down the sides of foundation piles. This had also been seen under the old furnaces and was later found under the process house.

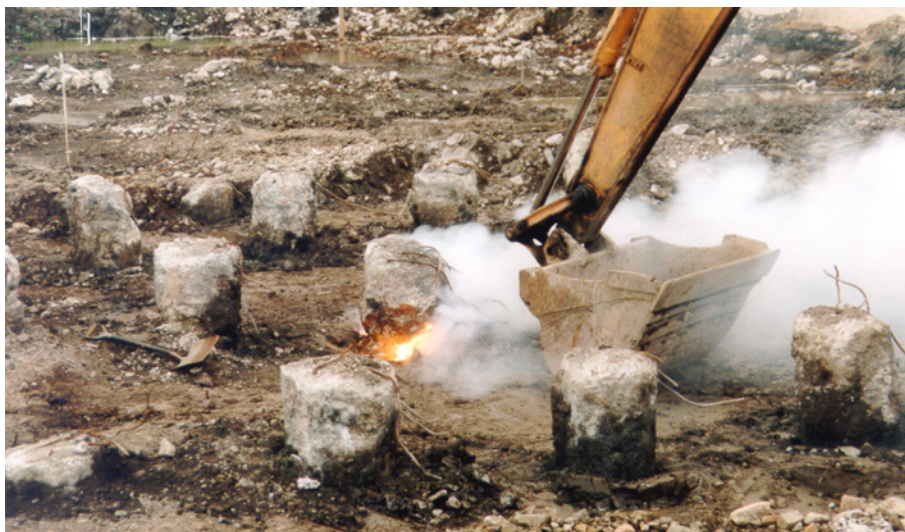
### Phosphorus around piles

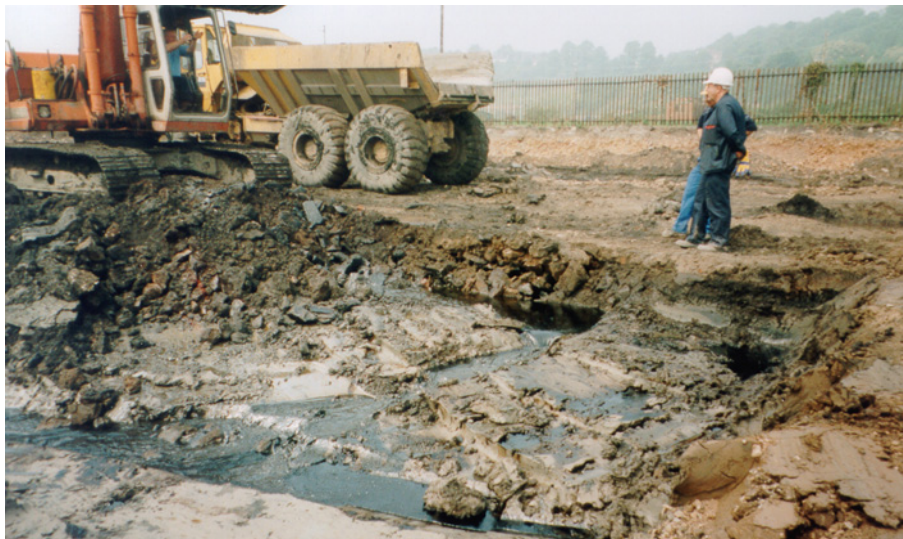
## Oil

The 1995 site investigation works had uncovered crude oil contamination in some areas but the absence of oil sheens or other visible hydrocarbons in the large water filled pits which then occupied part of the northern site, appeared to support the notion that the oil contamination was of relatively limited extent. Provision was made in the schedules for site disposal of an estimated 25,000m<sup>3</sup> of oily material. However, as the clearance work progressed into the former oil refinery, it became apparent that the volumes of contaminated material had been significantly underestimated as rubble and oil filled basements; tank pads and pipelines were uncovered. It also proved very difficult to limit cross-contamination when for example oil filled pipes embedded in apparently clean clay were breached.

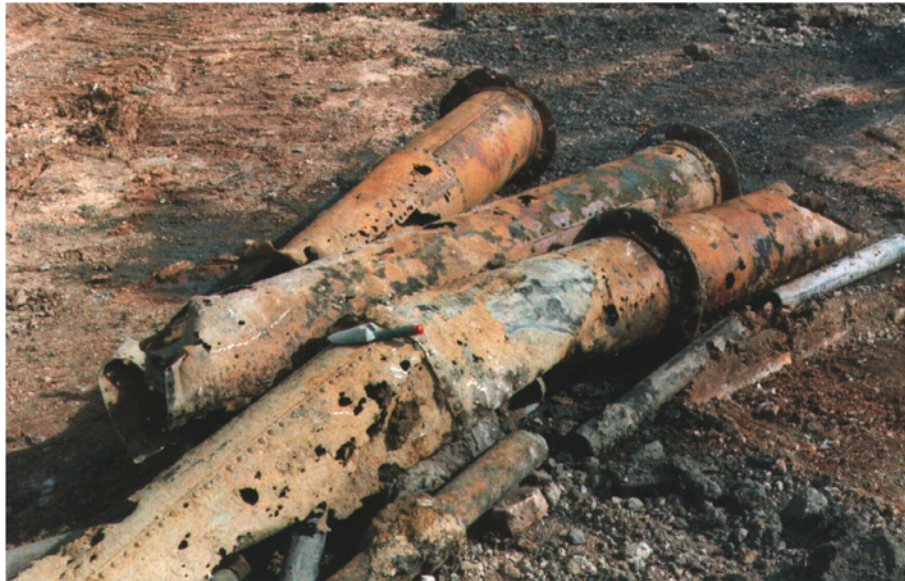
## Old pipework
